**Melbourne
Water**

Environmental Compliance

Quarterly Report

January-March 2000

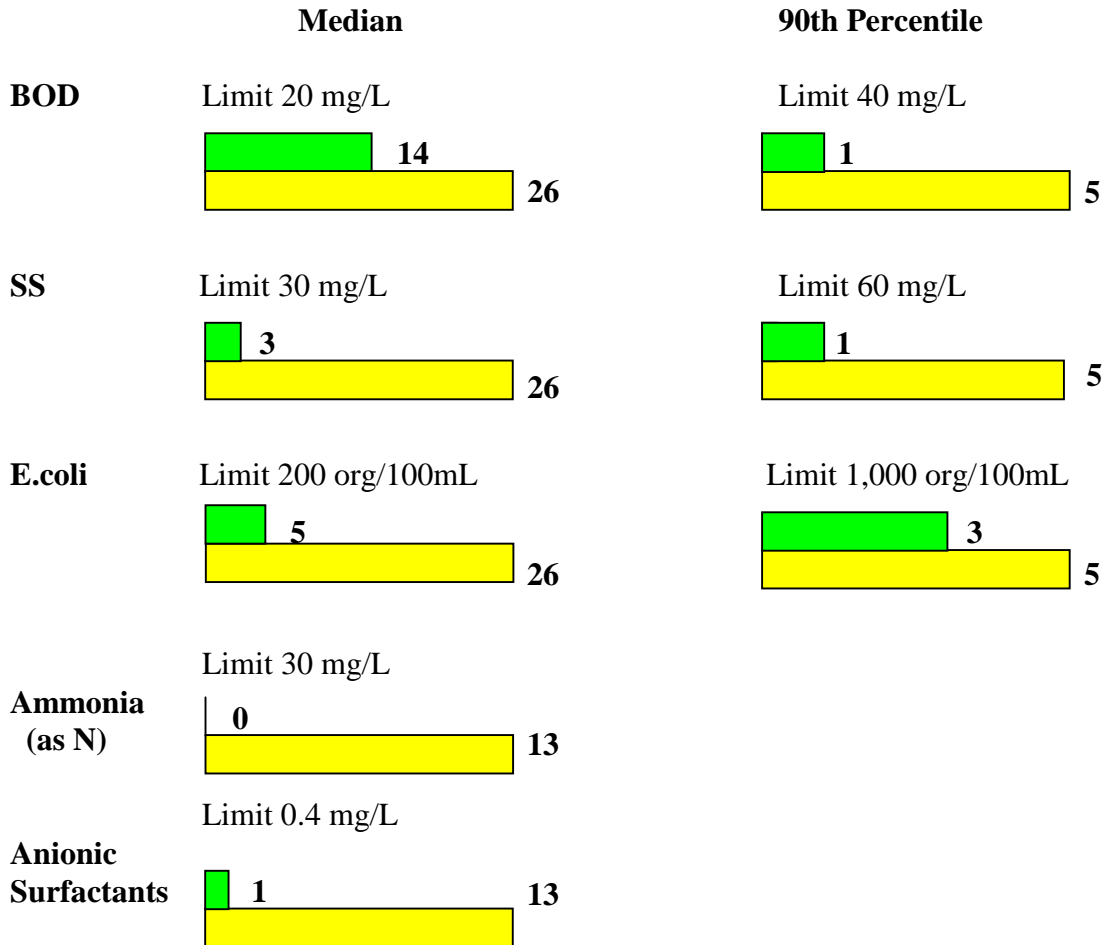
The following details eastern Treatment Plant's performance for critical parameters. Performance with respect to other parameters is reported here only if the results exceed licence limits, in which case explanatory information is contained in the following section (iii).

Number of sample results to date greater than the Licence Limit - exceeds the total allowance for the year (licence breach).
	Number of sample results to date greater than the Licence Limit - exceeds the allowance for the year to date.
	Number of sample results to date greater than the Licence Limit - within the allowance for the year to date.
	Number of sample results during the year allowed to exceed the Licence Limit.

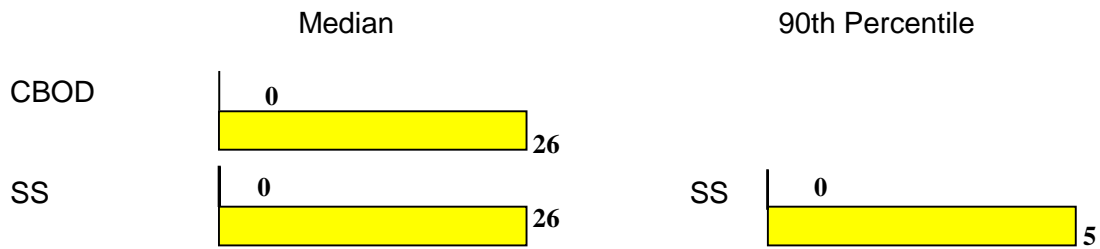
(i) Annual Parameters - flow weighted average of all four licensed outlets

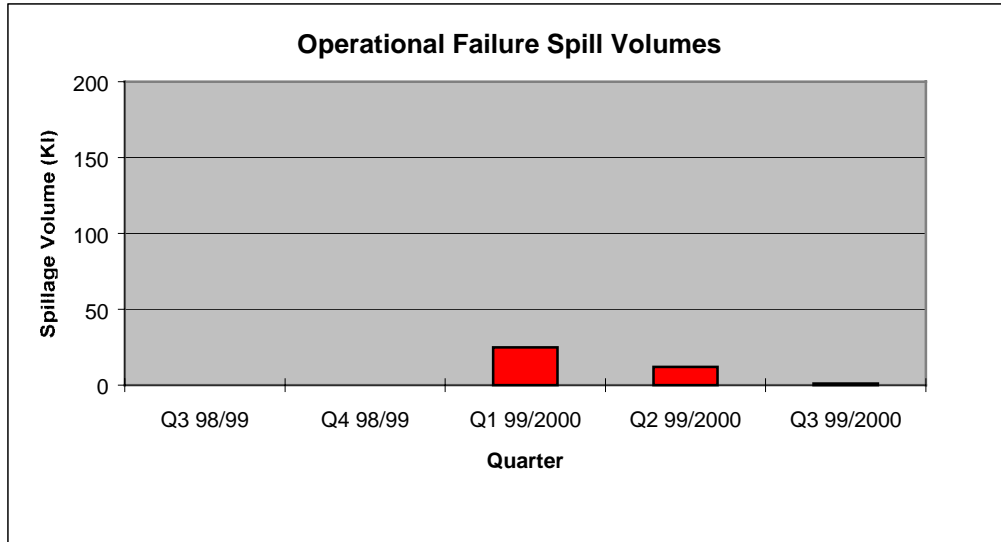
The above graph indicates the volume of sewage spilt due to equipment breakdown or human error

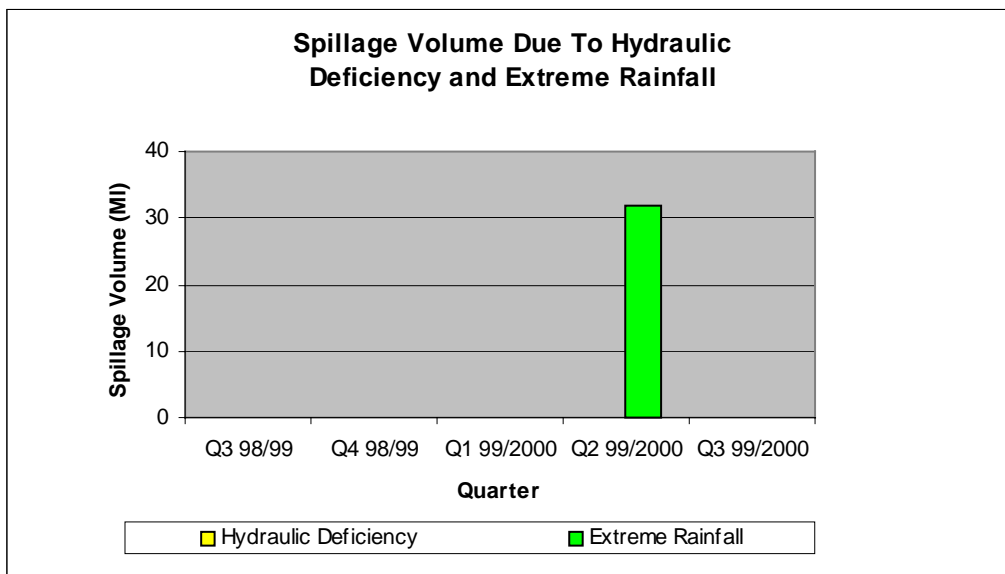
Hydraulic Deficiency - Spills due to insufficient pipe/pump capacity

Extreme Rainfall - Spills due to rainfall events greater than 1: 5 year return frequency

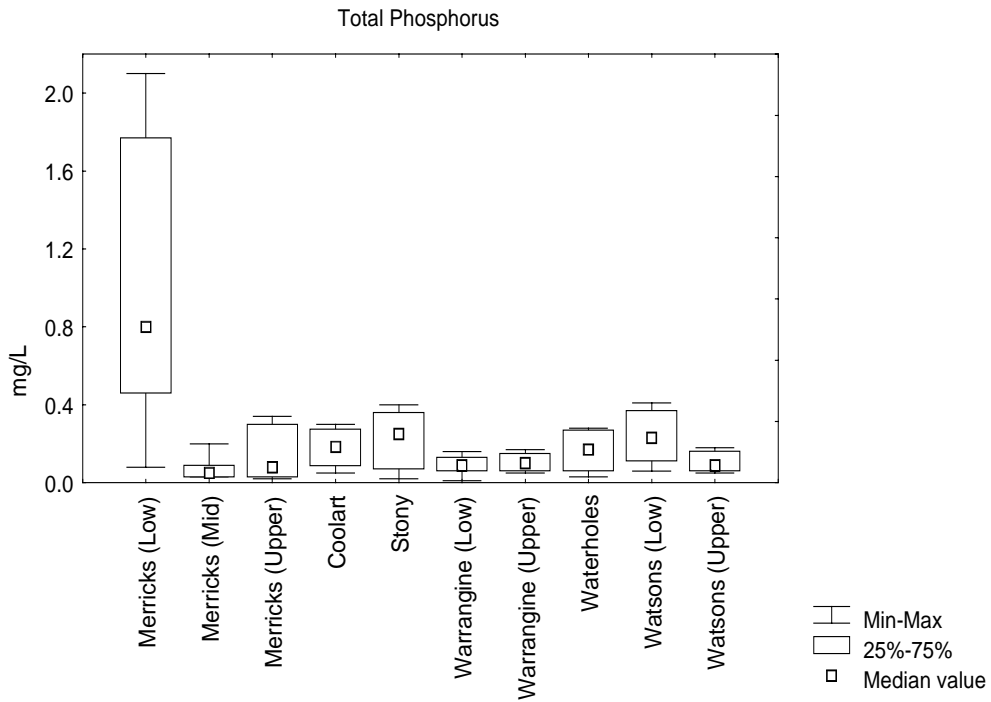
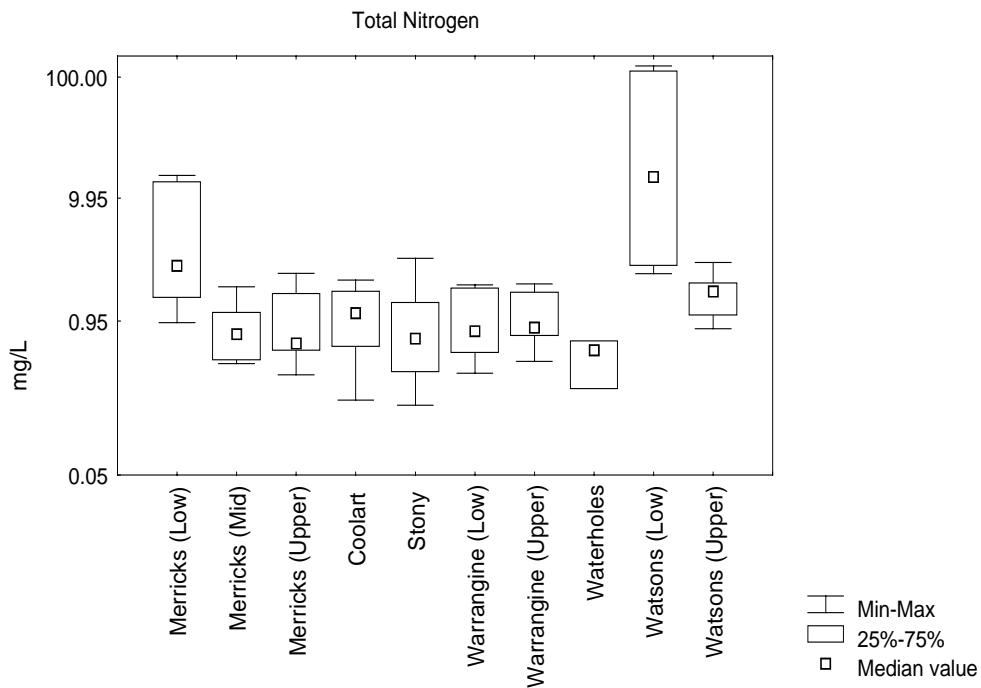
The following graphs show the levels of Total Phosphorus and Total Nitrogen in Mornington Peninsula streams flowing into Westernport. The graphs were compiled by Australian Water Technologies using Melbourne Water’s historical data and data collected by sampling programs.
